Basin Glove: Disposable Wash Basin Liner in the Prevention of HAIs

By: Eugene_Muro, Dr. Guillermo Ruiz, Justin Wise, Tiffany Turner, Dr. Jeffrey Langland Ph.D.

Date : June 11, 2018

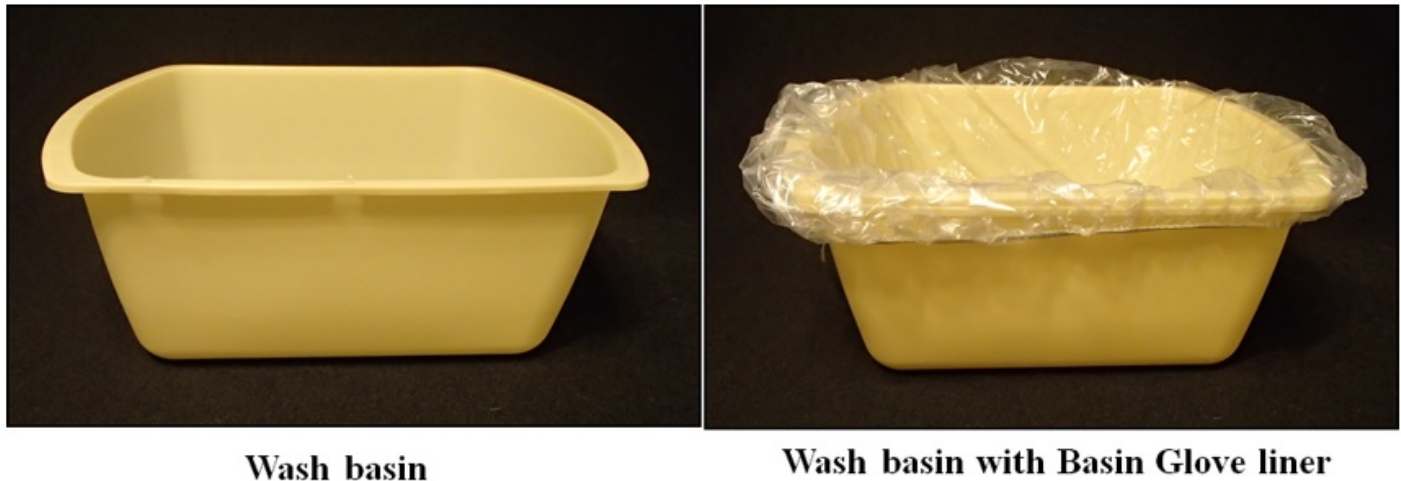
Figure 1. Typical wash basin with and without Basin Glove liner.

The purpose of this study was to evaluate the level of residual bacteria left in the wash basins following exposure to bacteria and a) not rinsing, b) rinsing with tap water, or c) lining the wash basin with a Basin Glove liner. An example of a typical wash basin with and without the Basin Glove liner is shown in Figure 1. Under our conditions, when the water basins were exposed to *E. coli* or MRSA without a rinse, there was over 100,000 CFU/cm² (Fig. 2). When the wash basins were exposed to the bacteria and then rinsed with tap water, approximately 20,000 CFU/cm² were present (Fig. 2). No growth was detected when the wash basins were covered with the disposable Basin Glove liner prior to bacterial exposure; minimum detection limit of 10 CFU/cm² (Fig. 2).

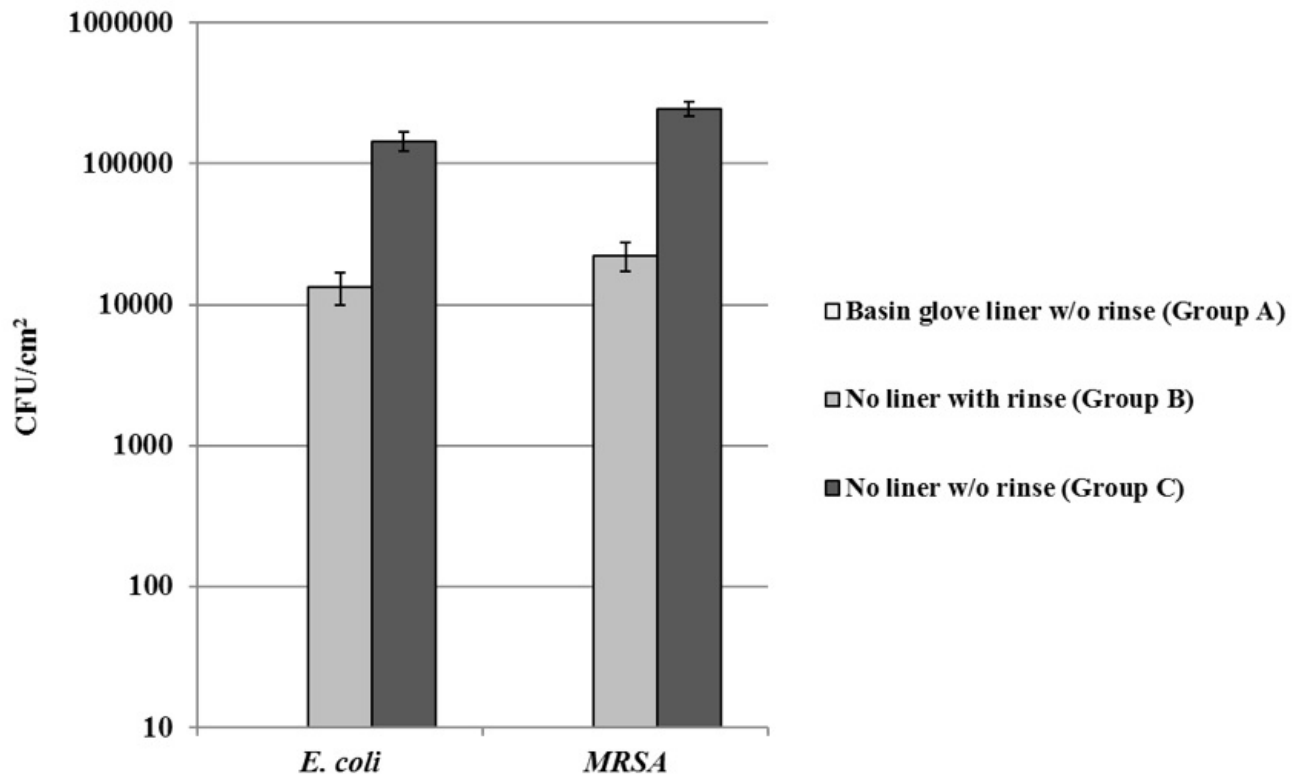
Figure 2. Reduction in CFU/cm² with wash basins lined with Basin Glove liner.

Wash basins with or without Basin Glove liner were exposed to *E. coli* or MRSA. Basins with no liner were either not rinsed or rinsed with tap water. Bacterial CFU/cm² in each basin after treatment is shown. Values shown with error bars represent the mean +/- SEM of 10 replicate samples for each treatment. A paired t-test of Group A vs. Group B or Group C resulted $p < 0.00001$ for both bacterial species.

Each group was replicated 10 times for validation and calculation of standard deviations. There was a reduction (>99.9%) in bacterial contamination when the wash basin was lined with Basin Glove compared to when the wash basin was exposed to *E. coli* or MRSA without a rinse (based on a detection limit of 10 CFU/cm²; Table 1). In addition, there was a reduction in *E. coli* and MRSA (>99.92% and >99.95%, respectively) contamination in wash basins lined with Basin Glove compared to wash basin exposed to bacteria and then rinsed with tap water (based on a detection limit of 10 CFU/cm²; Table 1).
